OPERATING EXPERIENCE WEEKLY SUMMARY

Office of Nuclear and Facility Safety

October 30 - November 5, 1998

Summary 98-44

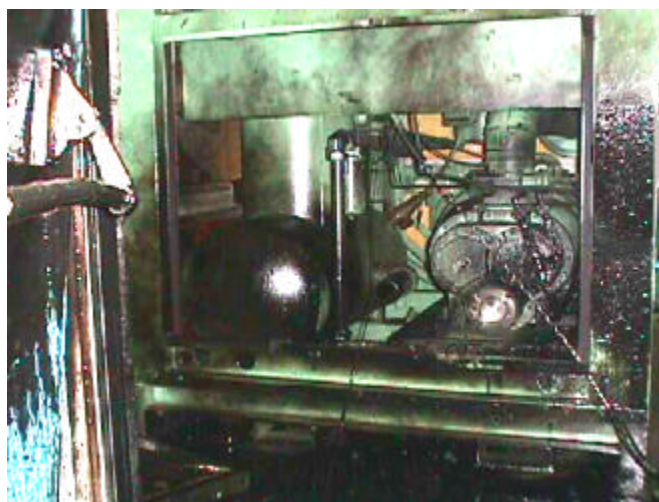
On November 4, 1998, at the Idaho National Engineering Environmental Laboratory Waste Experimental Reduction Facility, an operator was thrown against an air receiver and into a concrete wall from the concussion following a catastrophic air compressor failure. Compressor parts, debris, and oil were propelled into the south end of the compressor room, immediately filling it with atomized lubricating oil and smoke. The operator activated a manual fire alarm as he exited the room, evacuating the building. He was dazed and covered with a dark oil spray, but otherwise uninjured. The facility fire department responded to the scene and determined there was no fire. Fire department personnel and industrial hygienists released the building for entry after it had been properly ventilated, but access to the air compressor room has been restricted to preserve the accident scene until an investigation can be completed. Figure 1-1 shows the failed end of the air compressor. OEAF engineers will follow the accident investigation and provide information as it becomes available. (ORPS Report ID--LITC-WERF-1998-0008)

Figure 1-1. Air Compressor

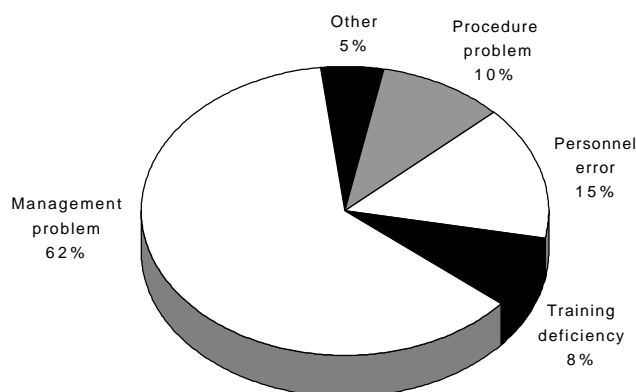
OEAF engineers searched the ORPS database for events involving expired qualifications and found 52 reports. Figure 7-1 shows the distribution of root causes for these occurrences. A review of these occurrences shows that managers reported management problems as the root cause in 62 percent of the occurrences for which a root cause was identified. Further review shows that managers attributed 50 percent of the management problems to inadequate administrative control and 28 percent to policy not adequately defined, disseminated, or enforced.

Figure 7-1. Root Causes for Expired Qualifications¹

These events illustrate the need for training coordinators, facility managers, and access control system administrators to review their training program records and controls to ensure that staff are qualified and certified for the tasks to which they are assigned. Employees should also accept the responsibility for meeting qualification requirements. Supervisors should be able to easily track the status of training for workers so that training can be scheduled in an effective manner.

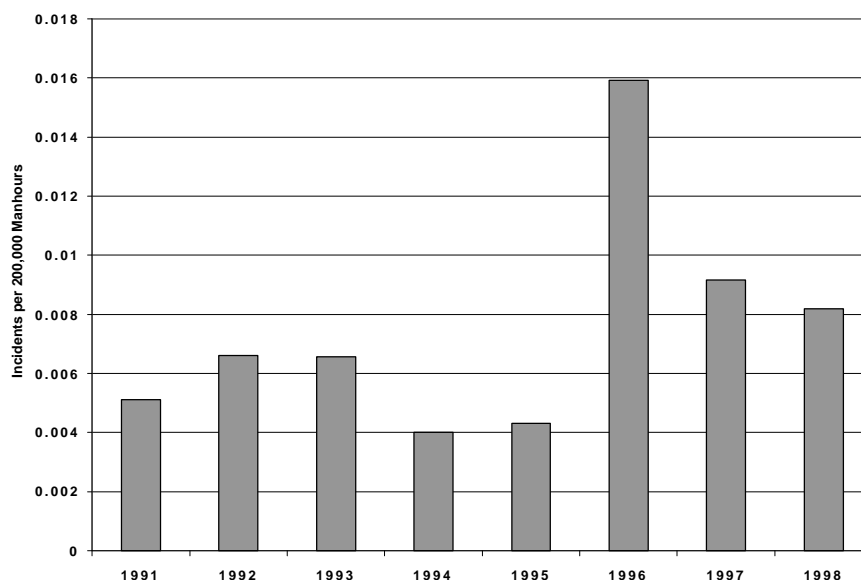
OEAF engineers searched the ORPS database for reports involving a lack of fall protection and found 95 occurrences. Rates and the trend of occurrences were established by normalizing the number of occurrences to the number of hours worked. Reporting of fall protection issues was relatively constant until the first quarter of 1996, when a fall fatality occurred at Idaho National Laboratory. After the Idaho event, DOE facilities apparently became more aware of the safety issues involved and were finding and reporting more occurrences. However, this trend has declined since 1996, and occurrences are currently being submitted at a slightly higher rate than before the Idaho event. Figure 8-1 shows the distribution of occurrences by year (note that the data for 1998 is not data for the full year) versus the number of occurrences per 200,000 hours worked.

Figure 8-1. Lack of Fall Protection Events²

DOE facility managers should review requirements and procedures to ensure that employees are familiar with both site and OSHA requirements for fall protection when elevated work is being performed. OSHA requires that an employee engaged in elevated work be protected from falling by (1) a guardrail system, (2) a safety net system, (3) a personal fall-arrest system, or (4) a combination of a warning line system and guardrail system or a warning line system and a safety monitoring system. Employees performing elevated work on platforms 50 feet or less in width are required to use a safety monitoring system.
